Dispelling myths in kiln mechanics

When mechanical issues are detected on a kiln, speculation and myths are rife, leading to confusion, uncertainty or even incorrect measures being taken. While the symptoms are usually easy to identify, root causes of and the solutions to the issue are harder to come by.

■ by **TomTom-Tools GmbH**, Switzerland

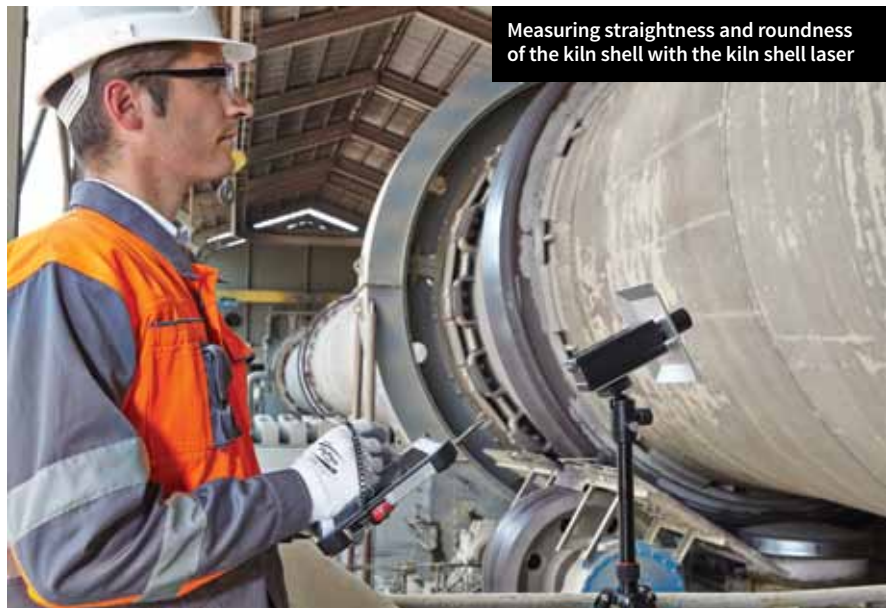
Measuring straightness and roundness of the kiln shell with the kiln shell laser

To measure the roundness and the above-mentioned straightness of the kiln, a distance laser sensor is placed beside the kiln from where it measures the deformation. One or two kiln rotations are sufficient to display the shape of the measured cross-section. The measurement is repeated, typically every 1 or 2m along the kiln, until the whole kiln is displayed as a 3D model.

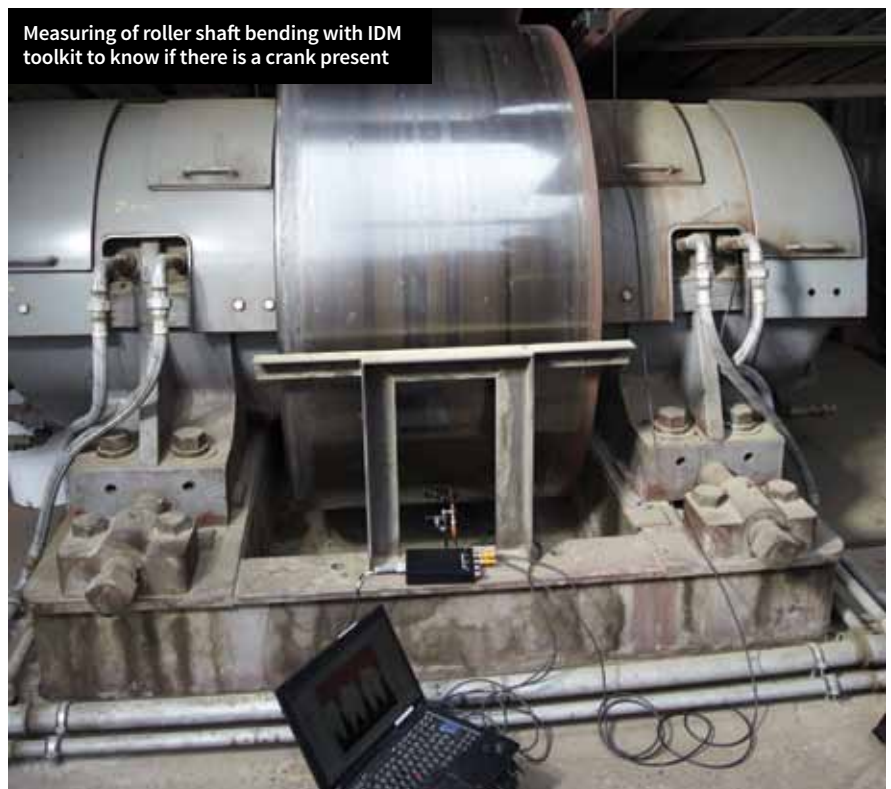
Measuring of roller shaft bending with IDM toolkit to know if there is a crank present

The cyclical load changes on the support rollers caused by the cranks are pushing the rollers slightly out of the normal position whereas the roller shafts are bending. This movement can be measured with inductive sensors under the rollers.

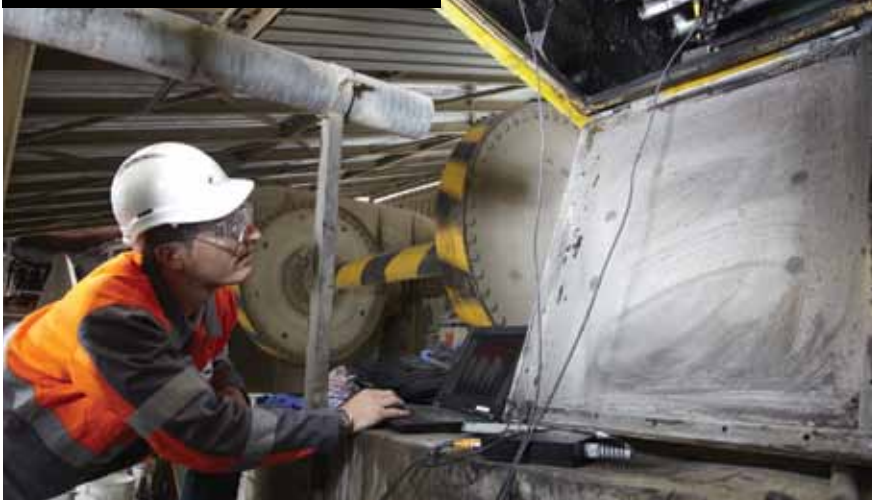
Measuring axial and radial run-out of the girth gear with an inductive distance measurement (IDM) tool kit. It is used in the same way to measure the wobble of kiln tyres

The axial run-out can be measured during normal kiln operation. To do so, contactless sensors are placed at one side of each tyre and changes in distance are collected and analysed.
